Marine Coating Testing Five Years in a Tidal Stream

Final Report 2017 Coppercoat

Reference: PMA 139

Client: Coppercoat

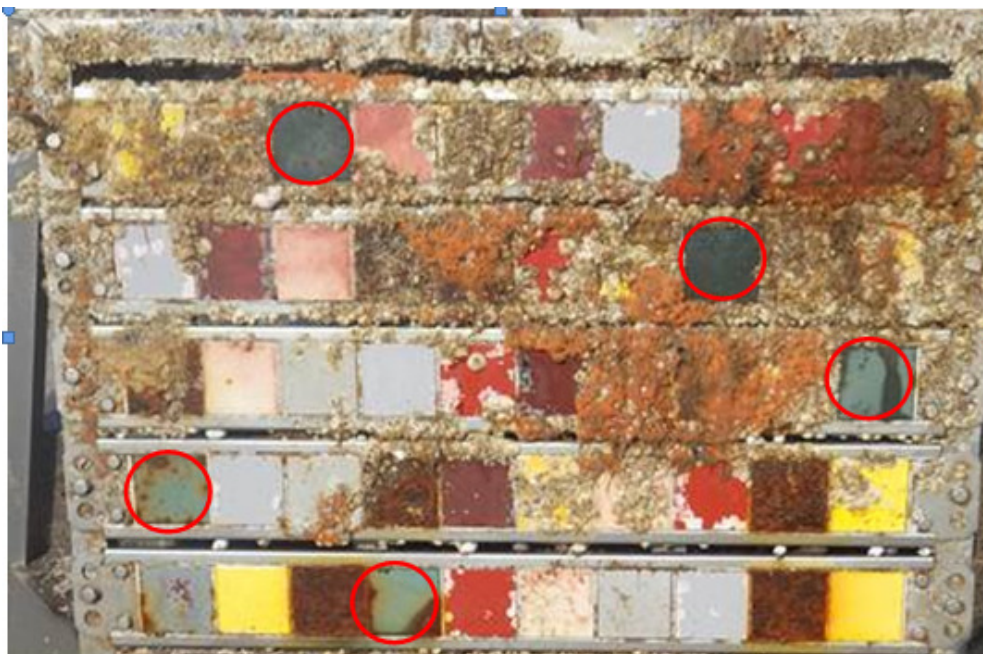
The abundance of fouling and coating damage was highly variable between coating types. Within each coating type, the position on the pod appeared to influence the amount of fouling present, with substantially less fouling on the lower two rows of the pod, presumably where scouring by mobile sediment had occurred.

Figure 3: Image of whole pod following recovery in 2017 after 60 months *in-situ*.

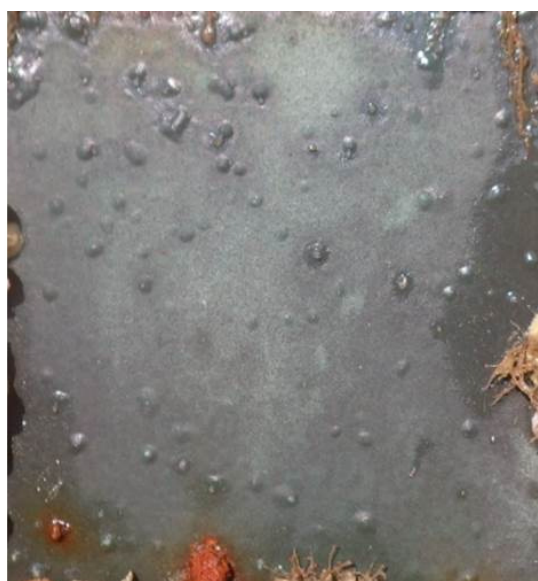
Figure 4: Example of Coppercoat coating following 60 months *in-situ* exposure in a tidal race.
All panels are 12x 12 cm².

Coppercoat had performed very well for the first four years, but several of the panels began to show signs of blistering and detachment after 5 years. However, where these systems remained intact, they also generally remained effective in preventing fouling.

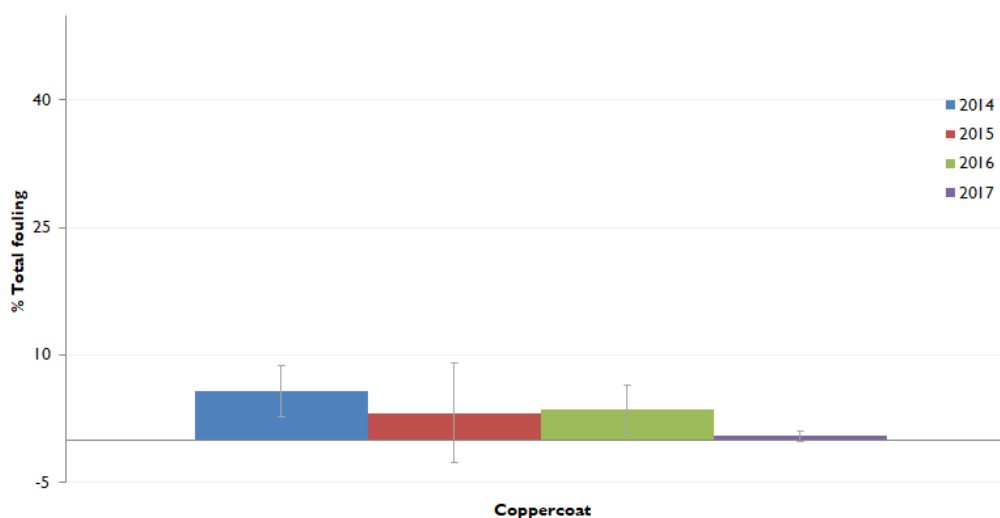
In most cases, the total abundance of fouling decreased over time from 2014, 2015 and 2017, and then usually increased during 2017. The exception in this trend were the “control” coatings – user applied – both of which failed extensively by 2015. By 2015, both of these panel types were essentially unprotected mild steel and covered in severe corrosion. To be noted that Coppercoat’s levels of fouling continued to decrease through 2017.

Figure 5: Total percentage cover of fouling from 2014 – 2017 based on ROV data or coarse level image analysis. Error bars indicate standard deviation. n= 10 in 2014, 10 in 2015, 9 in 2016 and 10 in 2017.

Coppercoat was among the top 3 systems with the lowest level of fouling which generally remained at below 10% coverage by fouling between 2014–2017.

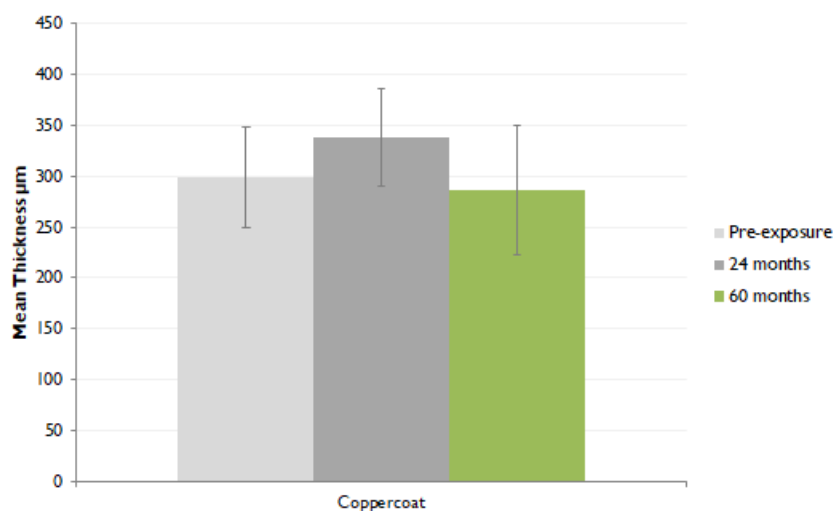
Coppercoat showed little significant change in thickness over time, excluding inter-panel variability.

Both user applied coating systems had disappeared almost entirely. The remained steel panels had corroded to such an extent that the blistering appeared to show an increase in thickness, but in reality very little if any coating matrix remained in place

Figure 6: Mean coating thickness pre-exposure, at 24 months and 60 months. Error bars show standard deviation, and n=3.
